REMEDIAL MEASURES FOR
HOUSES DAMAGED BY
EXPANSIVE CLAY

April 5, 1978

The University of Texas at Arlington
Under Contract No. H-2240-R

U.S. Department of Housing and Urban Development
Office of Policy Development and Research

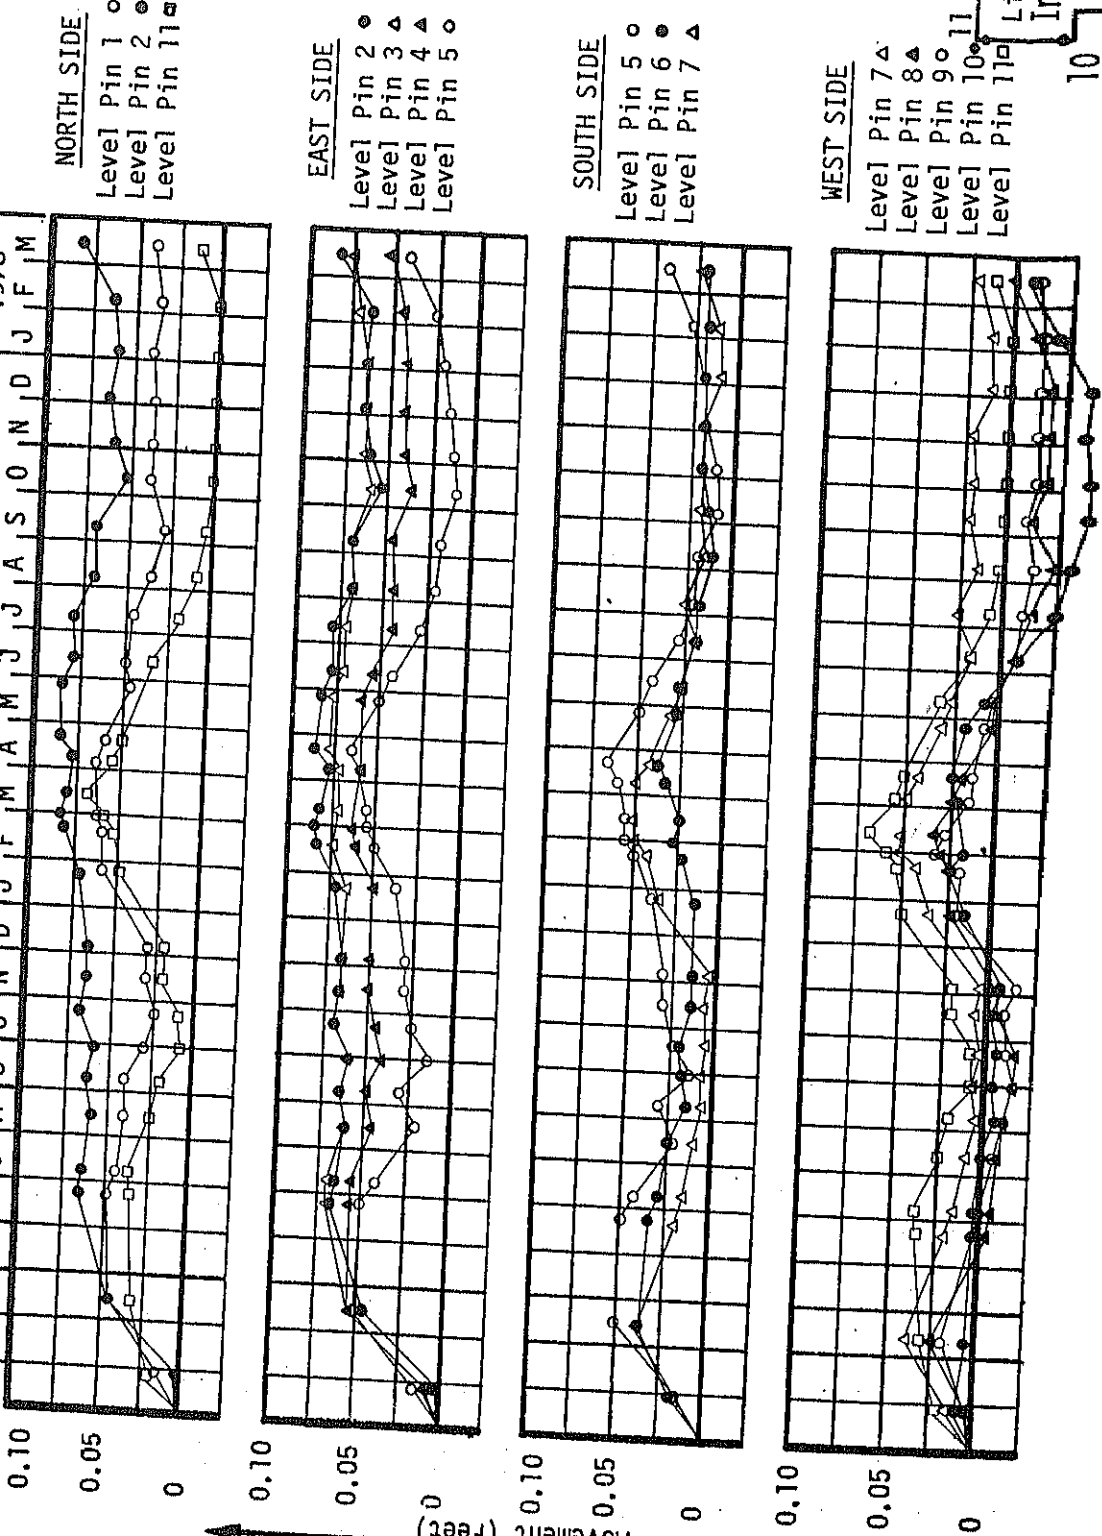
Fig. 11 Vertical Movement

An increase in vertical movement occurred as expected due to the development of double layer water on the clay minerals. This increase will continue until equilibrium is reached and then fluctuate with climatic cycle. The vertical movement increase was related to the amount of moisture available, the degree of desiccation of the foundation soil, and the amount of clay minerals in the montmorillonite group present in the soil to the depth of moisture migration.

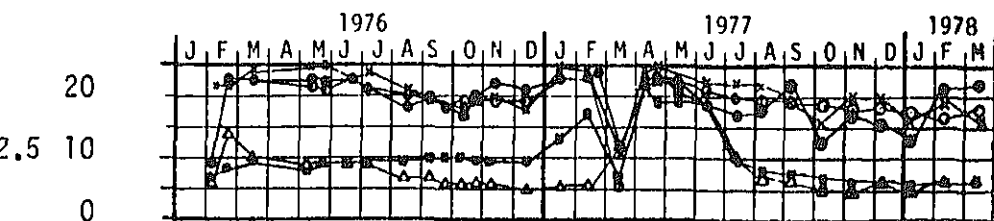
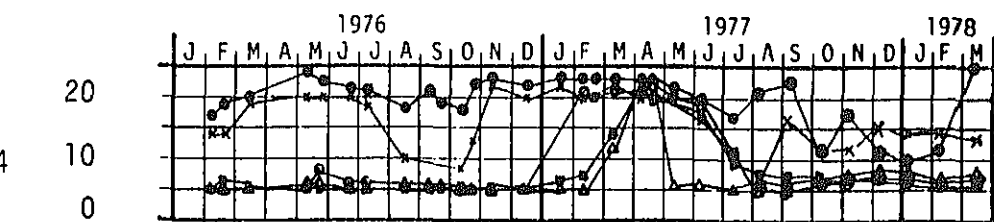
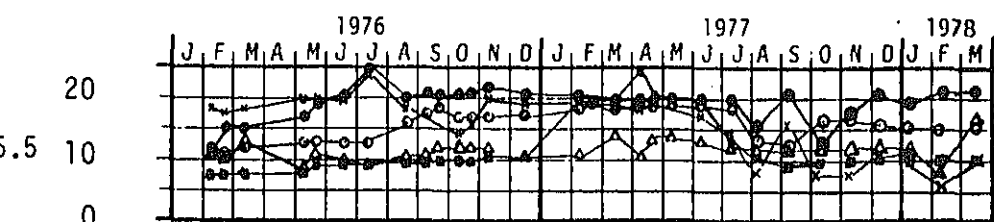
Fig. 16 Soil Moisture Content - Lime Slurry Injection
830 N.E. 32nd Street, Grand Prairie, Texas

The variation of soil moisture content with time for these two different geologic formations is as dramatic as the variation in vertical movements. From the soils investigation for these two houses, the soil properties such as natural water content, Plastic Limit, and Liquid Limit were significantly higher in the Taylor formation, or the house located on Mesquite Drive, Mesquite, Texas. Further, the natural water content of the soil at 7 foot depth for the Taylor formation was significantly lower than the Plastic Limit of the soil. Within depths of interest in this investigation, the maximum amount of soil moisture variation was as much as 11% below the Plastic Limit in the Taylor formation, whereas in the Eagle Ford formation 5% below the Plastic Limit appeared to be maximum. In addition, the percentage of montmorillonite clay minerals determined by x-ray Diffraction Analysis was much greater in the Taylor formation than in the Eagle Ford formation. For depths of 7 feet from the soil surface, the increase (in what) was as much as 45 percent at the 7 foot elevations and 20 percent at the 7 foot depth. The lime slurry was laterally inserted to this depth; however, the extent of the moisture migration vertically and laterally along fissures and planes of weakness was unknown, and would be a function of the degree of desiccation and past geologic history. However, it is believed that moisture migration was wide spread for pressures of 150 psi, and both, the vertical movements and moisture migration support this premise.

The high specific surface area of montmorillonite clay minerals (100 square meters per gram), along with the large volume of water introduced into the profile of the house located on the Taylor formation versus the house on the Eagle Ford formation indicates the subsoil under the house at Mesquite, Texas, was capable of retaining more moisture. Reference is made on page 30, which compares the maximum perimeter differential movement for the house where the subsoil was treated by lime slurry pressure injection. This figure indicates the significant difference in activity of the subsoil for the houses on the Taylor and Eagle Ford formations. Similar indications are given by comparing Figures 11 and 13, pages 22 and 26, which show

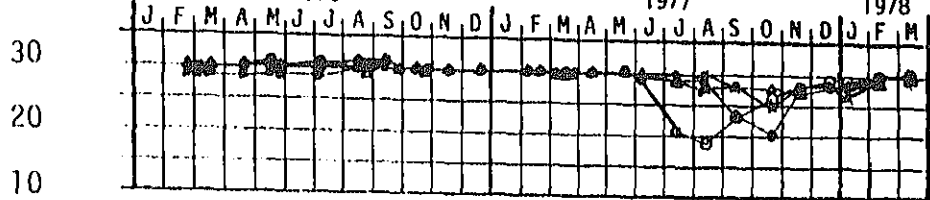
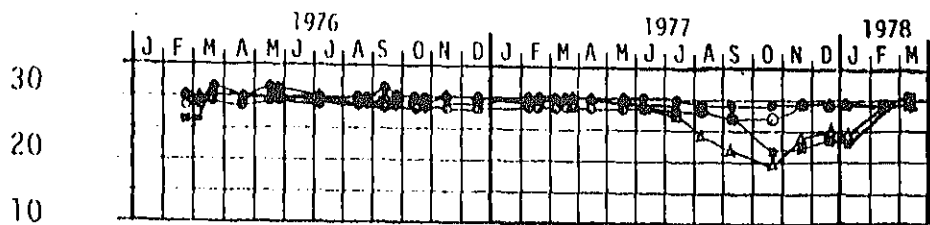
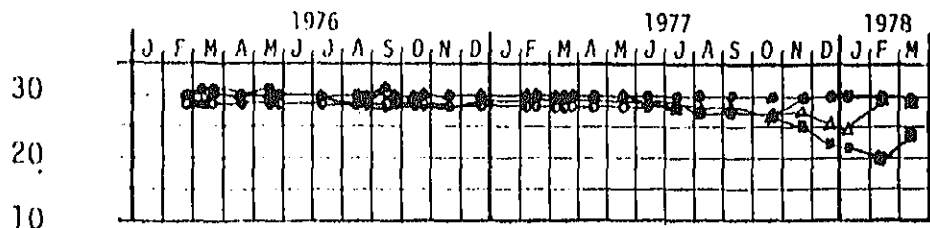
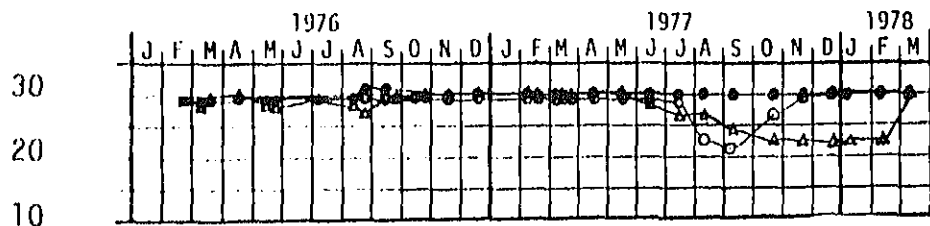
* Refers to Depths Below Perimeter Grade Beam
 Fig. 36 Soil Moisture Content - Rubber Barrier
 1314 Athens Street, Mesquite, Texas

is submitted that an undetermined volume of the added water was lost to significant depths in the subsoil and also to soil outside the rubber barrier by the ready avenues of escape provided by fractures and cracks in the formation subsoil. As the soil expanded and gradually restricted these flow paths, the increase in soil moisture was obtained in the soil mass surrounded by the rubber barrier.

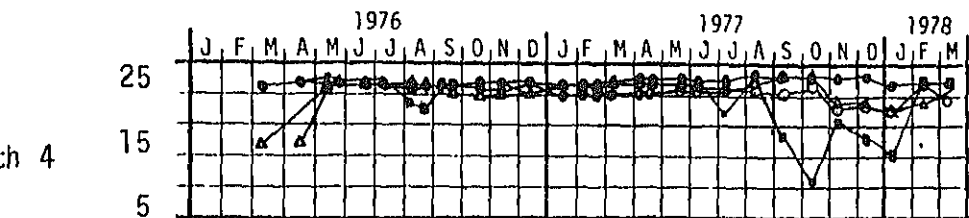
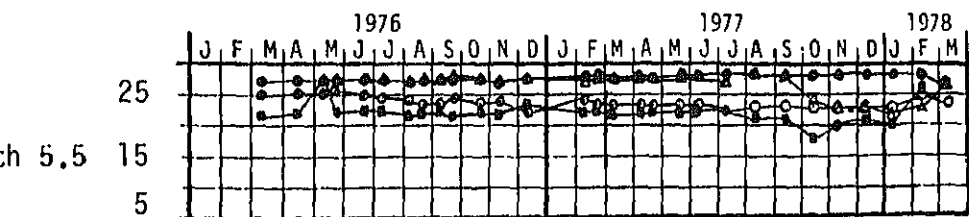
Fig. 43 Soil Moisture Content - Lean Concrete Barrier
1137 Eastwood Drive, Lewisville, Texas

The average Plastic Limit in the upper five feet of the soil at this test house was 24.75 percent. As indicated by Figure 43, the minimum requirement for the soil moisture to be a minimum of 2-3 percent above the Plastic Limit was not achieved for certain depths and different sides of the house. While some reading error is apparent in certain instances, the moisture content as taken from the moisture-temperature cells was not increased to the desired level.

As given in Section 4.4.1, 9,827 gallons of water were added to the soils beneath the floor slab and surrounded by the concrete barrier. Further, the entire volume of water was added to the soil from the interior of the house. The floor slab had a "cupped" configuration, and borings were made through the slab on the interior of the house governed by the high and low points determined by topographical survey. Further, testing of the soils in the upper five feet to determine whether or not the moisture content was increased to the minimum desired was also accomplished at the access points from the interior of the house. The moisture-temperature cells are installed in borings approximately 12-18 inches from the house perimeter which may result in the moisture gradient decreasing and recording less than the optimum of the instruments. If the preceding was the case, it is then possible that the installed instruments and the insitu soil do not have completely intimate contact resulting in readings that are less than desirable. The mass of soil enclosed by the vertical concrete barrier could have different moisture contents throughout and particularly have higher moisture contents at the in-

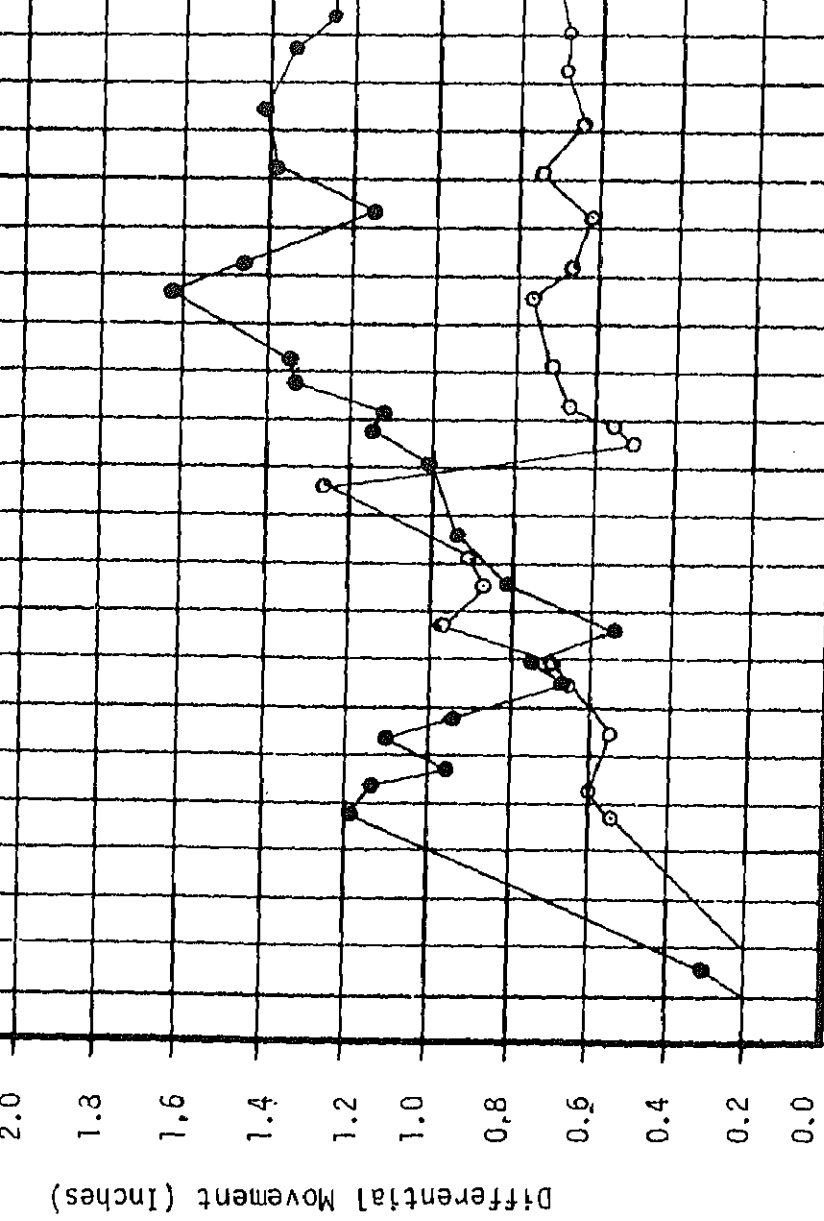
Fig. 51 Maximum Perimeter Differential Movement Comparison on Different Geologic Formations Sub-Surface Irrigation Sys

Comparison of the two test houses on two geologic formations is only possible during the period of time both systems are functioning. For this period, the SIS performed remarkable well on the Eagle Ford with vertical movements being approximately one half of the vertical movements for the house on the Taylor formation. Figure 51 and Tables 30 and 31 show absolute values of movement around the perimeter of the house. The data for the house at 5807 Fess Street, Dallas, Texas is factual. The data given for
